**DRAFT REPORT  
ROUND 10 DAM ASSESSMENT  
ALLIANT ENERGY – NELSON DEWEY GENERATING STATION  
SLAG POND, WPDES POND  
CASSVILLE, WISCONSIN  
NOVEMBER 15, 2011**

RE: DRAFT Assessment of Dam Safety of Coal Combustion Surface Impoundments at the  
Nelson Dewey Generating Station

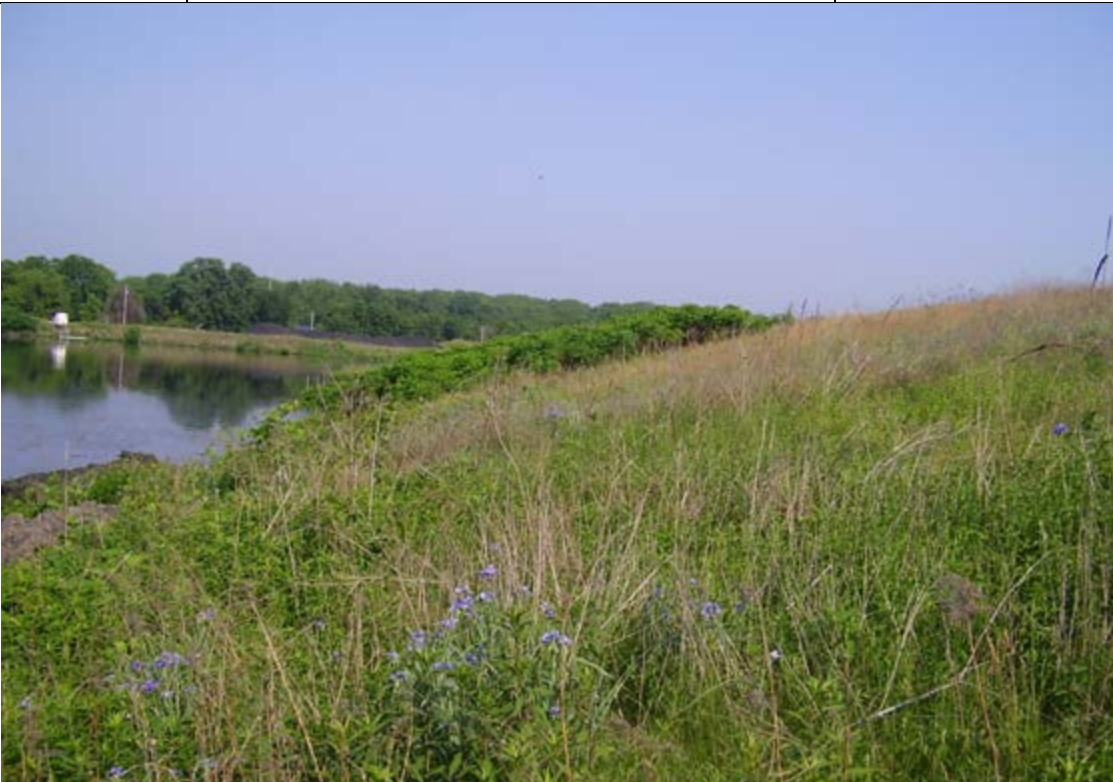
<b>Client Name:</b> U.S. EPA		<b>Site Location:</b> Nelson Dewey Generating Station Cassville, Wisconsin	<b>Project No.</b> 01.0170142.30
<b>Photo No.</b> <b>1</b>	<b>Date:</b> 6/7/11

<b>Direction Photo Taken:</b> Northwest			
<b>Description:</b> Upstream slope of the Slag Pond.

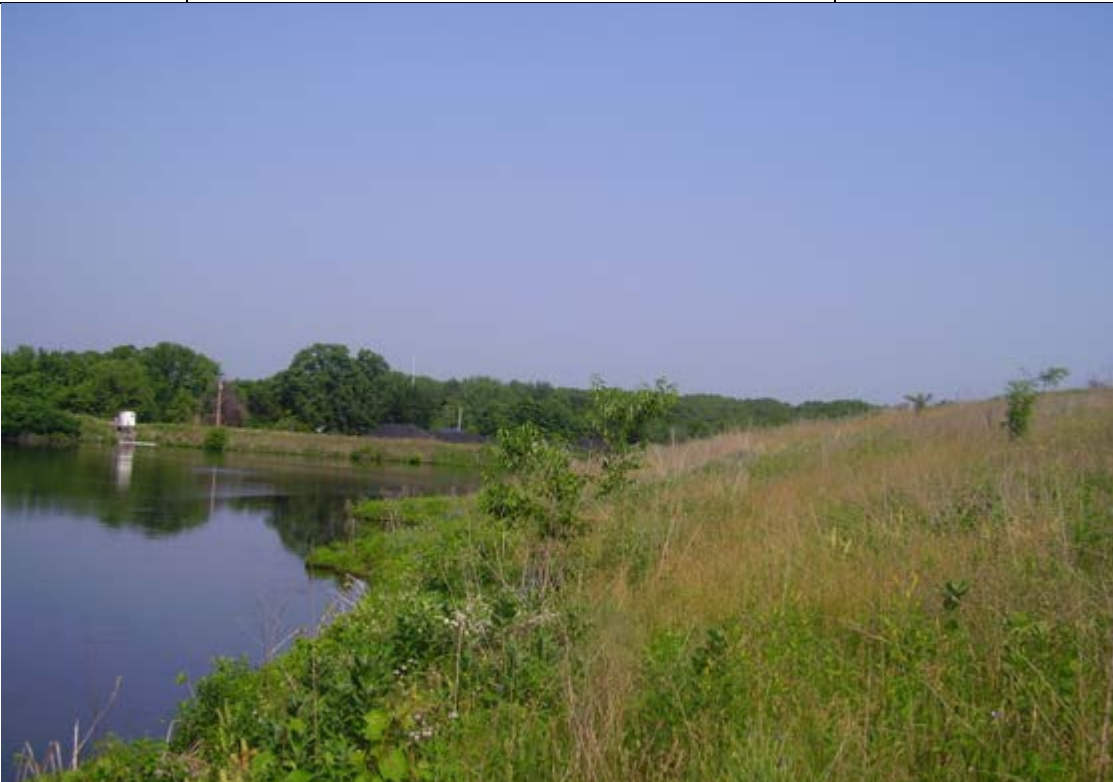
<b>Client Name:</b> U.S. EPA		<b>Site Location:</b> Nelson Dewey Generating Station Cassville, Wisconsin	<b>Project No.</b> 01.0170142.30
<b>Photo No.</b> <b>3</b>	<b>Date:</b> 6/7/11

<b>Direction Photo Taken:</b> Northwest			
<b>Description:</b> Upstream slope of the Slag Pond.

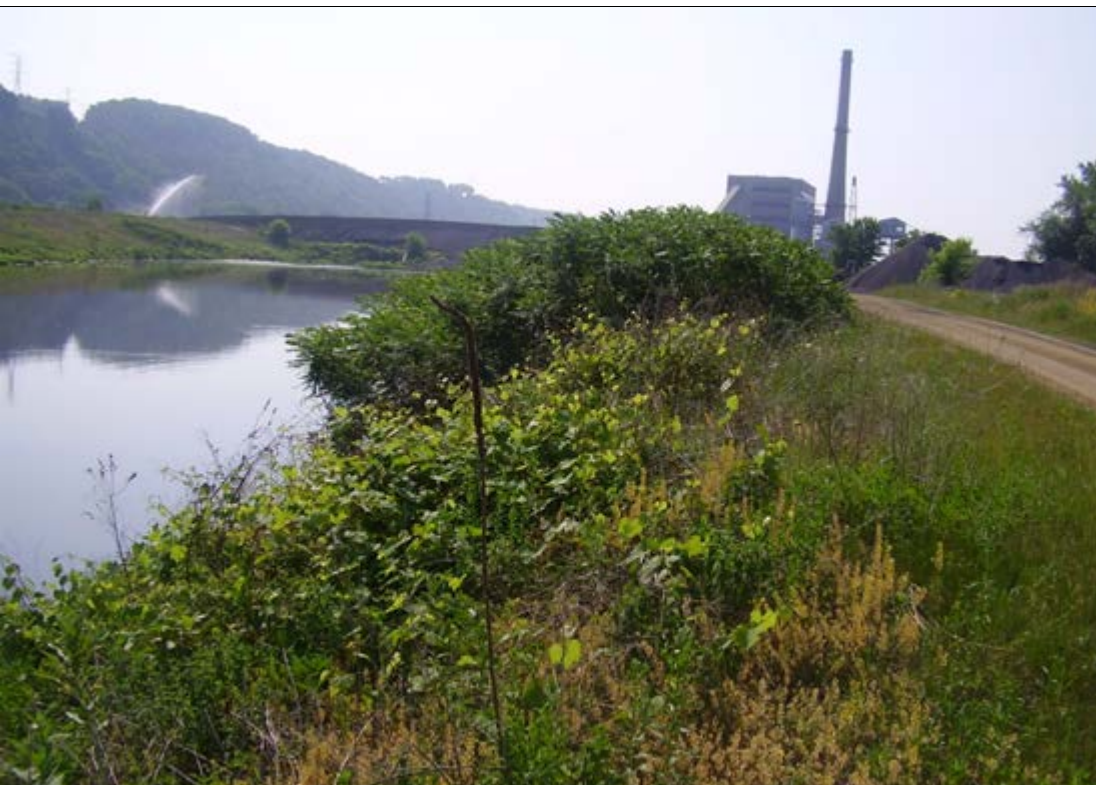
**Photo No.**  
**6**

**Description:**  
Upstream slope and crest of  
the Slag Pond.

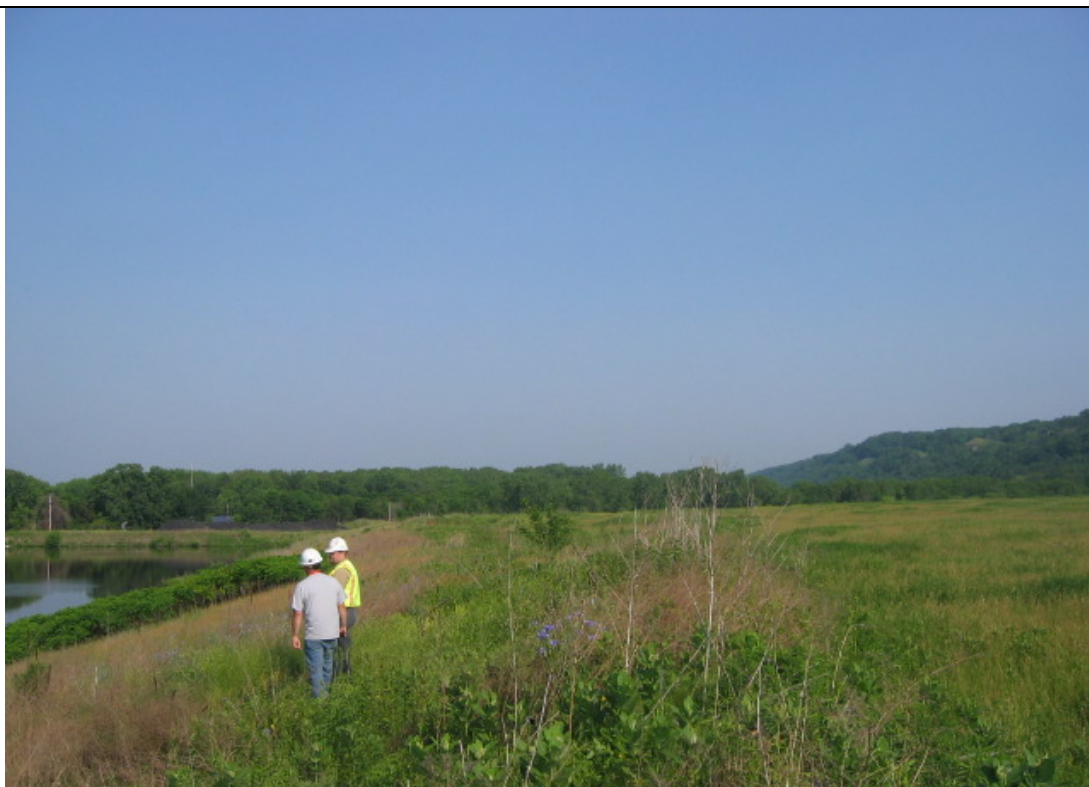
**Photo No.**  
**10**

**Description:**  
Crest of the Slag Pond.

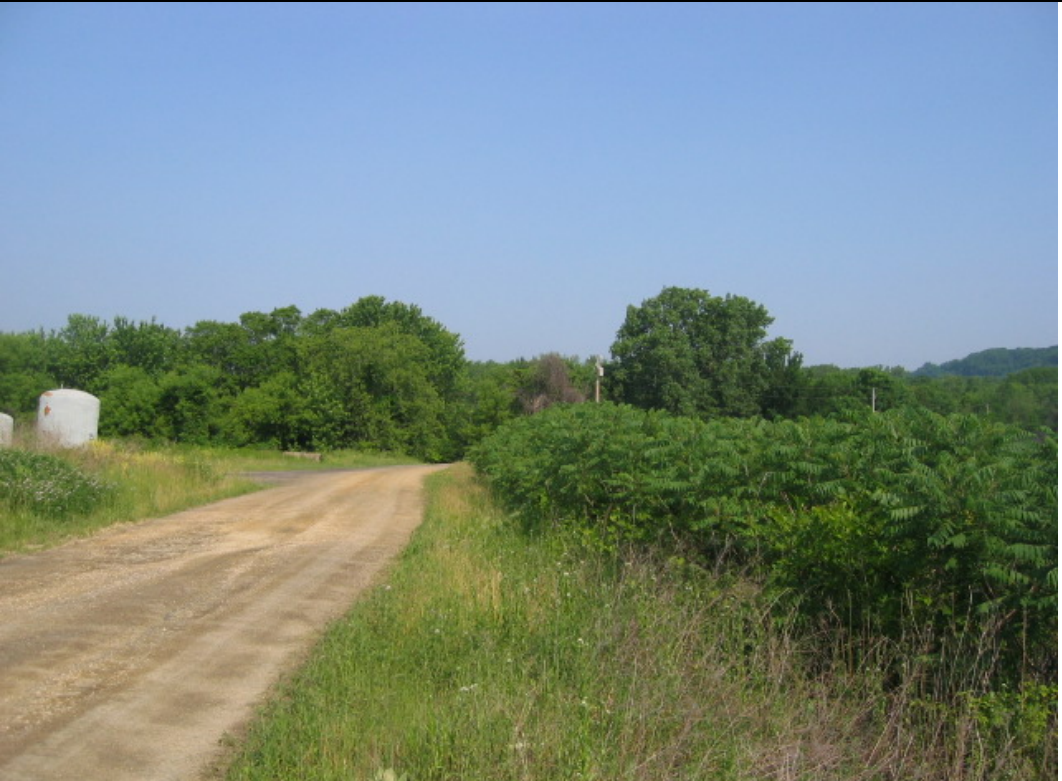
<b>Client Name:</b> U.S. EPA		<b>Site Location:</b> Nelson Dewey Generating Station Cassville, Wisconsin	<b>Project No.</b> 01.0170142.30
<b>Photo No.</b> <b>13</b>	<b>Date:</b> 6/7/11

<b>Direction Photo Taken:</b> Northwest			
<b>Description:</b> Crest of the Slag Pond.

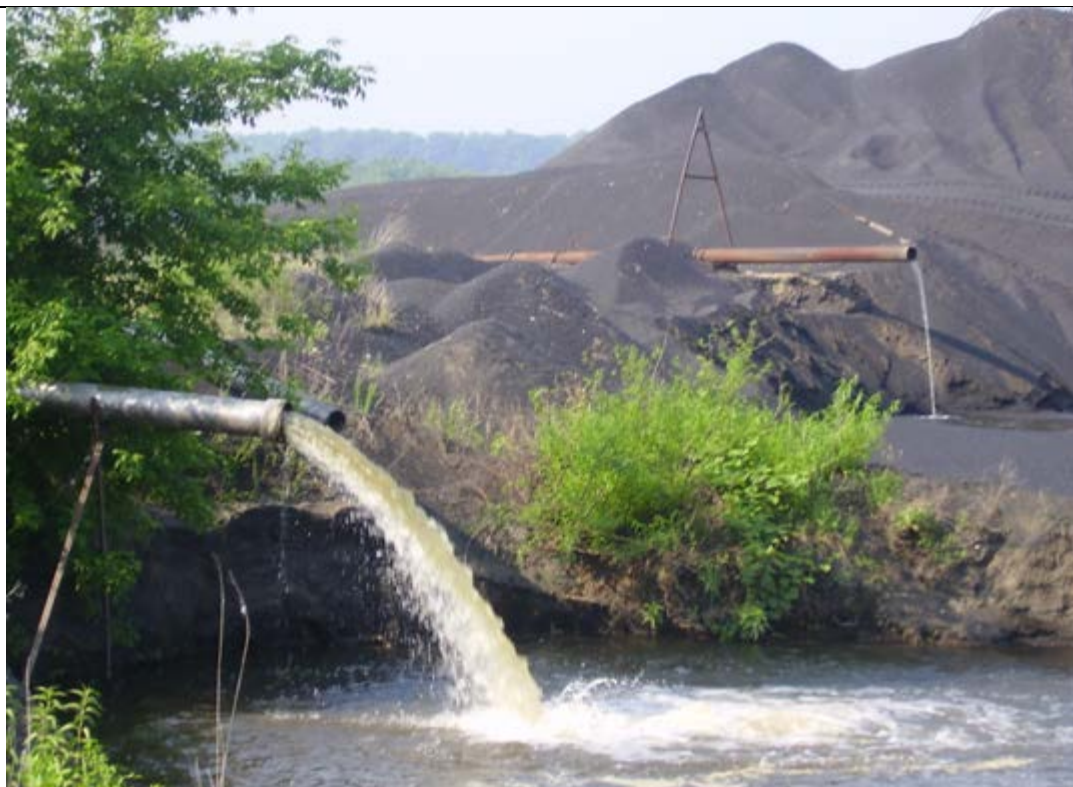
**Photo No.**  
**16**

Discharge pipes along the  
eastern embankment of the  
Slag Pond as seen from the  
north.

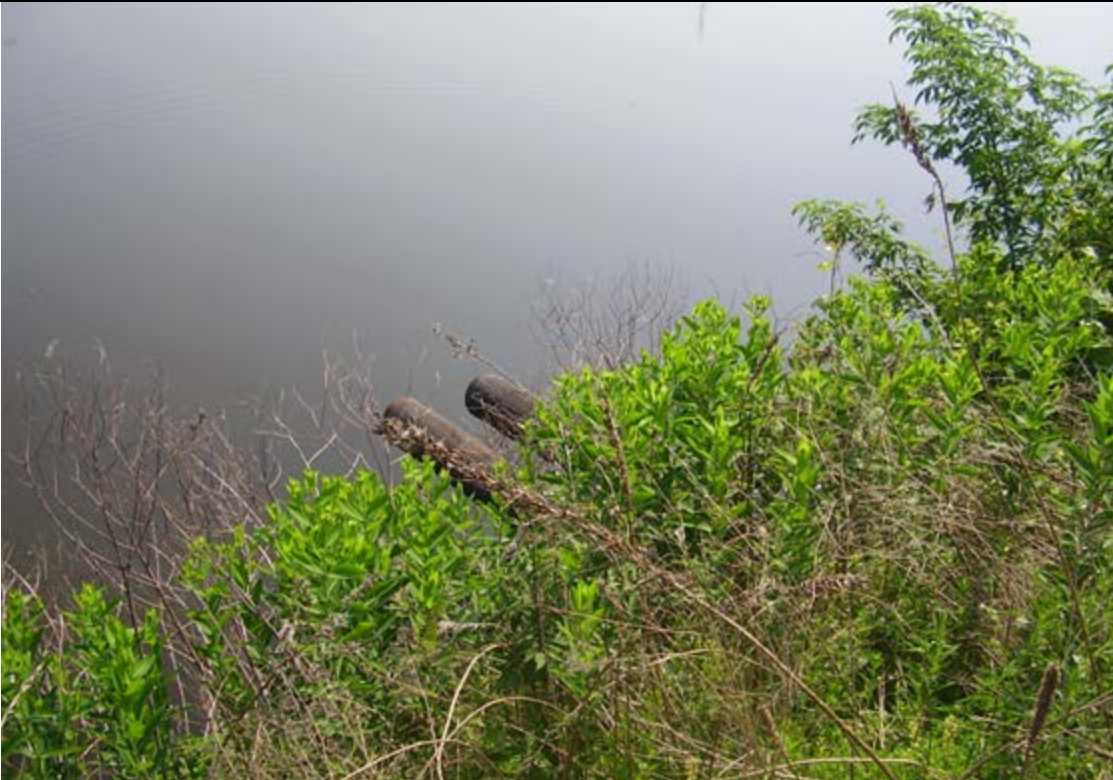
<b>Client Name:</b> U.S. EPA		<b>Site Location:</b> Nelson Dewey Generating Station Cassville, Wisconsin	<b>Project No.</b> 01.0170142.30
<b>Photo No.</b> <b>23</b>	<b>Date:</b> 6/7/11

<b>Direction Photo Taken:</b> Northeast			
<b>Description:</b> Discharge pipes into the Slag Pond.

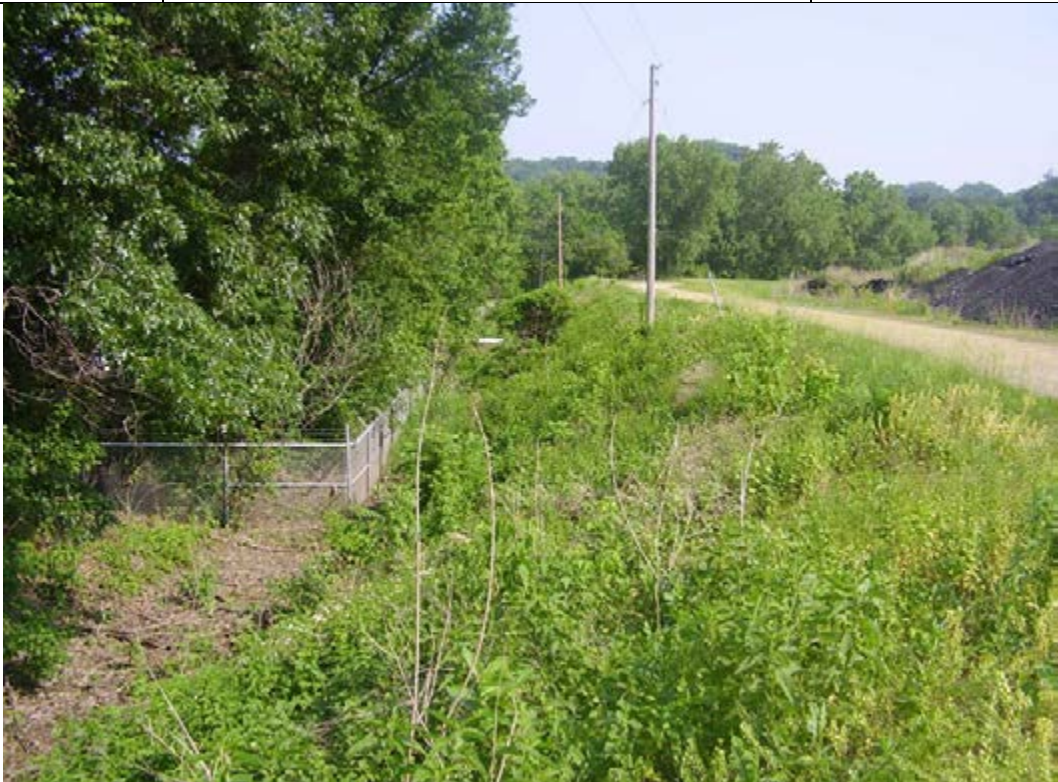
<b>Client Name:</b> U.S. EPA		<b>Site Location:</b> Nelson Dewey Generating Station Cassville, Wisconsin	<b>Project No.</b> 01.0170142.30
<b>Photo No.</b> <b>25</b>	<b>Date:</b> 6/7/11

<b>Direction Photo Taken:</b> North			
<b>Description:</b> Downstream slope of the Slag Pond.

1. Repair sloughing on the downstream slope of the Slag Pond;
2. Protect the northwestern embankment of the Slag Pond from wave action erosion; and,
3. Control burrowing animals on and near embankment
4. Fill animal burrows.

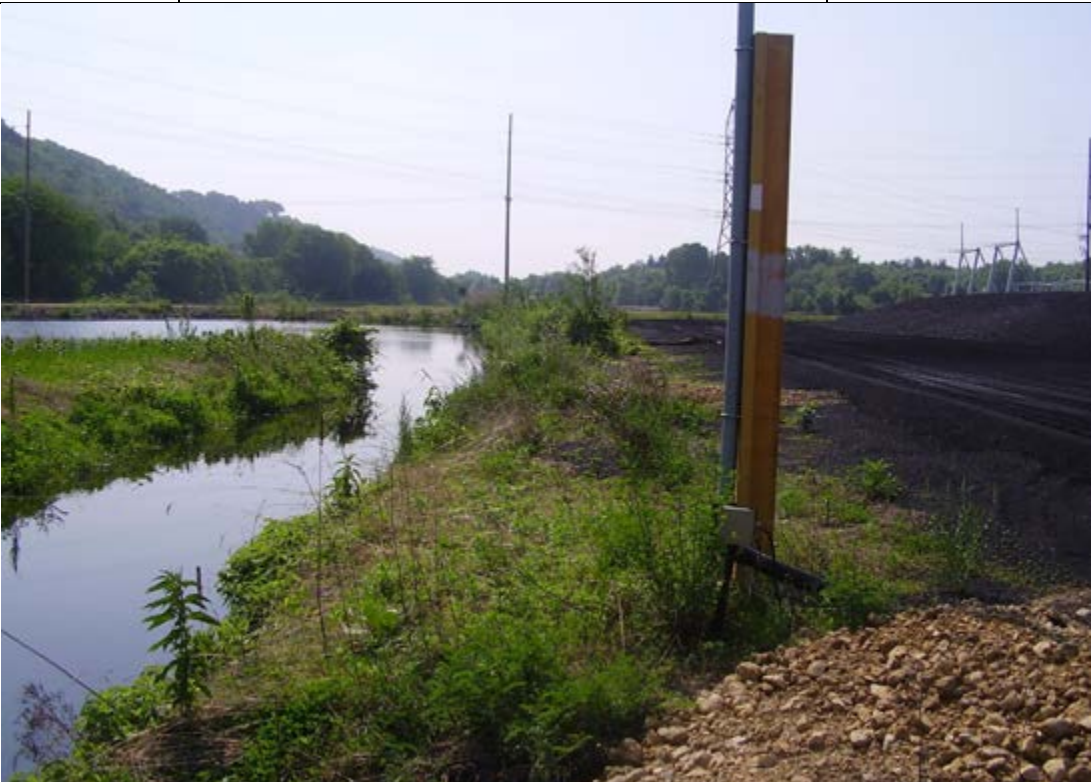
<b>Client Name:</b> U.S. EPA		<b>Site Location:</b> Nelson Dewey Generating Station Cassville, Wisconsin	<b>Project No.</b> 01.0170142.30
<b>Photo No.</b> <b>27</b>	<b>Date:</b> 6/7/11

<b>Direction Photo Taken:</b> Southeast			
<b>Description:</b> Upstream slope and crest of the WPDES Pond.

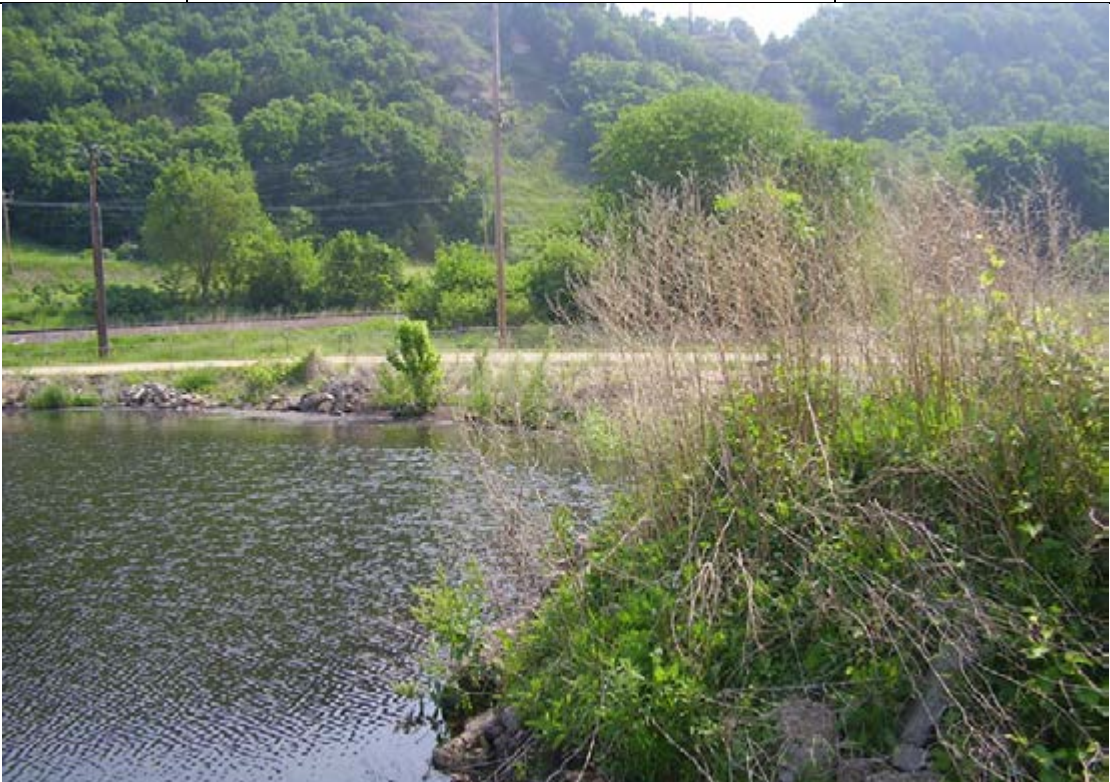
<b>Client Name:</b> U.S. EPA		<b>Site Location:</b> Nelson Dewey Generating Station Cassville, Wisconsin	<b>Project No.</b> 01.0170142.30
<b>Photo No.</b> <b>29</b>	<b>Date:</b> 6/7/11

<b>Direction Photo Taken:</b> East			
<b>Description:</b> Upstream slope of the WPDES Pond.

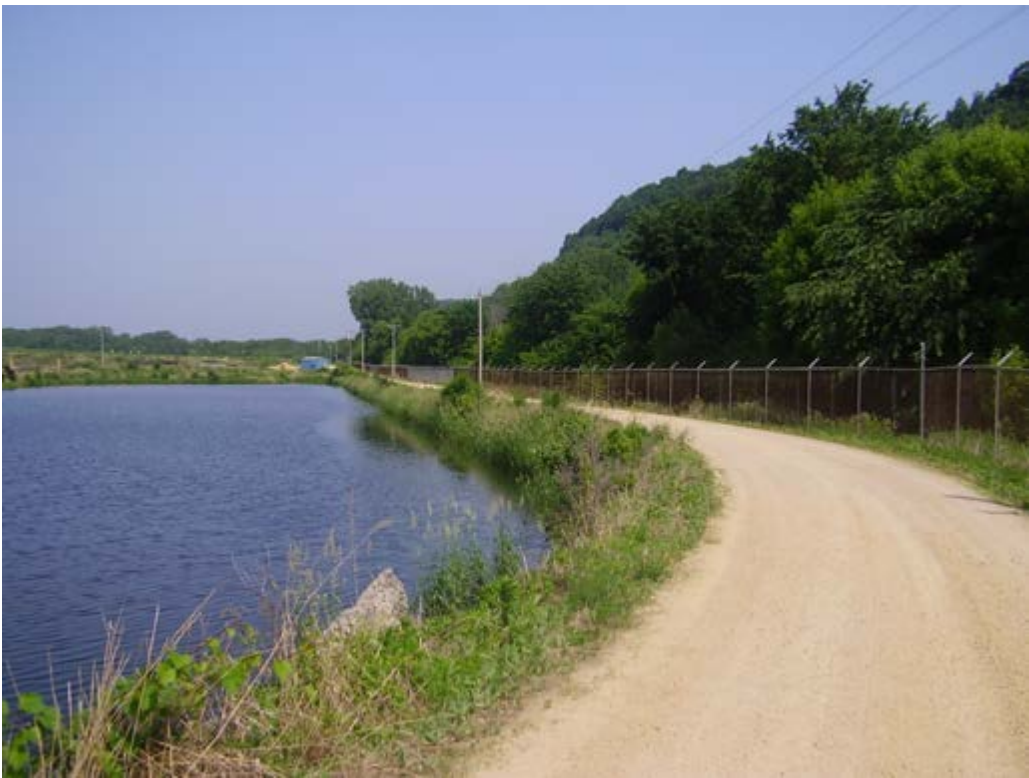
<b>Client Name:</b> U.S. EPA		<b>Site Location:</b> Nelson Dewey Generating Station Cassville, Wisconsin	<b>Project No.</b> 01.0170142.30
<b>Photo No.</b> <b>31</b>	<b>Date:</b> 6/7/11

<b>Direction Photo Taken:</b> Northwest			
<b>Description:</b> Upstream slope and crest of the WPDES Pond.

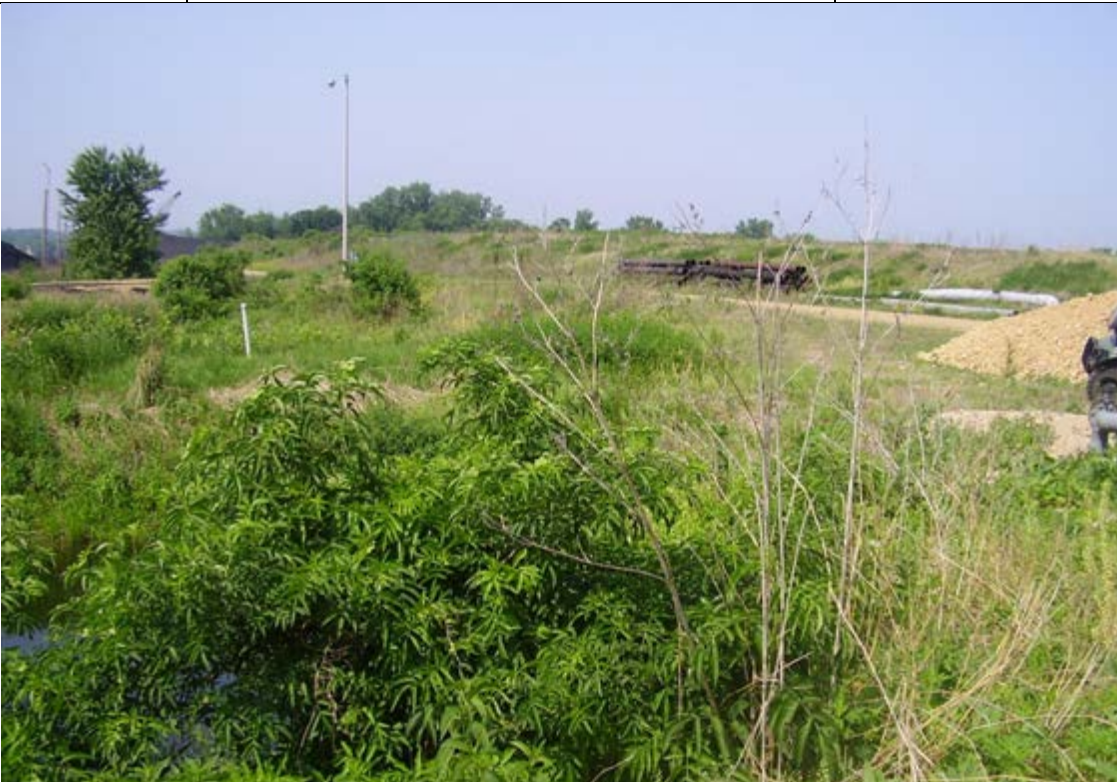
<b>Client Name:</b> U.S. EPA		<b>Site Location:</b> Nelson Dewey Generating Station Cassville, Wisconsin	<b>Project No.</b> 01.0170142.30
<b>Photo No.</b> <b>33</b>	<b>Date:</b> 6/7/11

<b>Direction Photo Taken:</b> Southwest			
<b>Description:</b> Upstream slope and crest of the WPDES Pond.

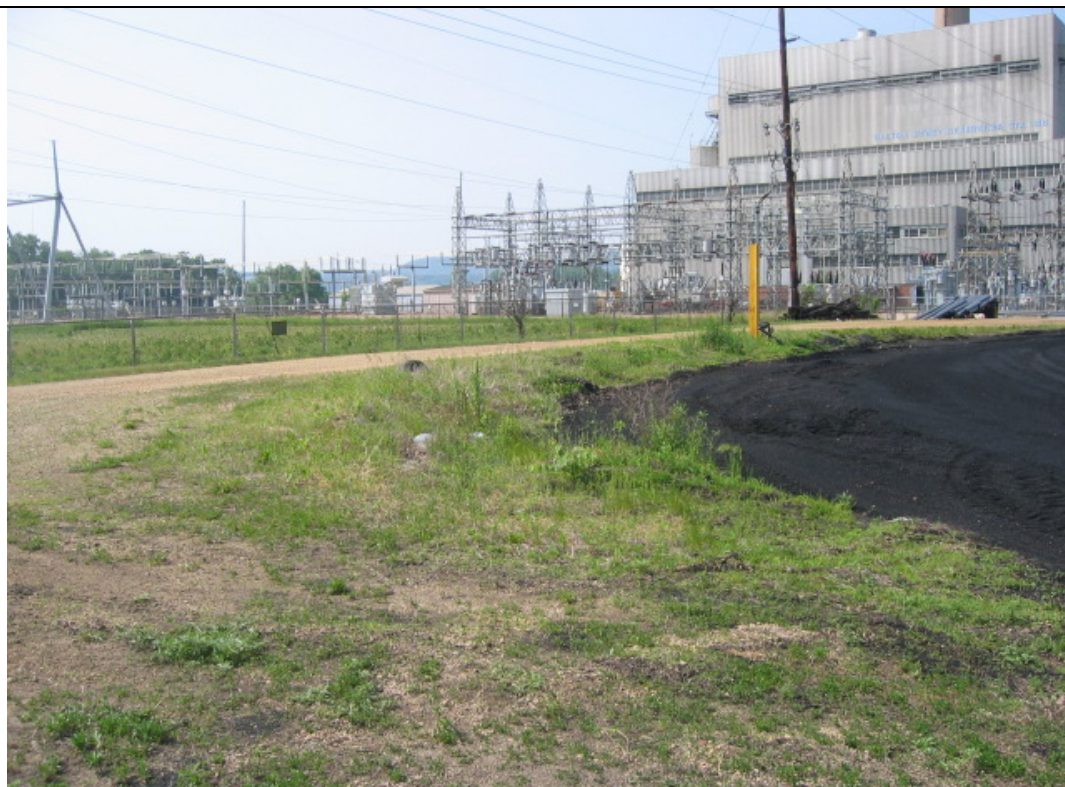
**Photo No.**  
**36**

**Description:**  
Crest of the WPDES Pond.

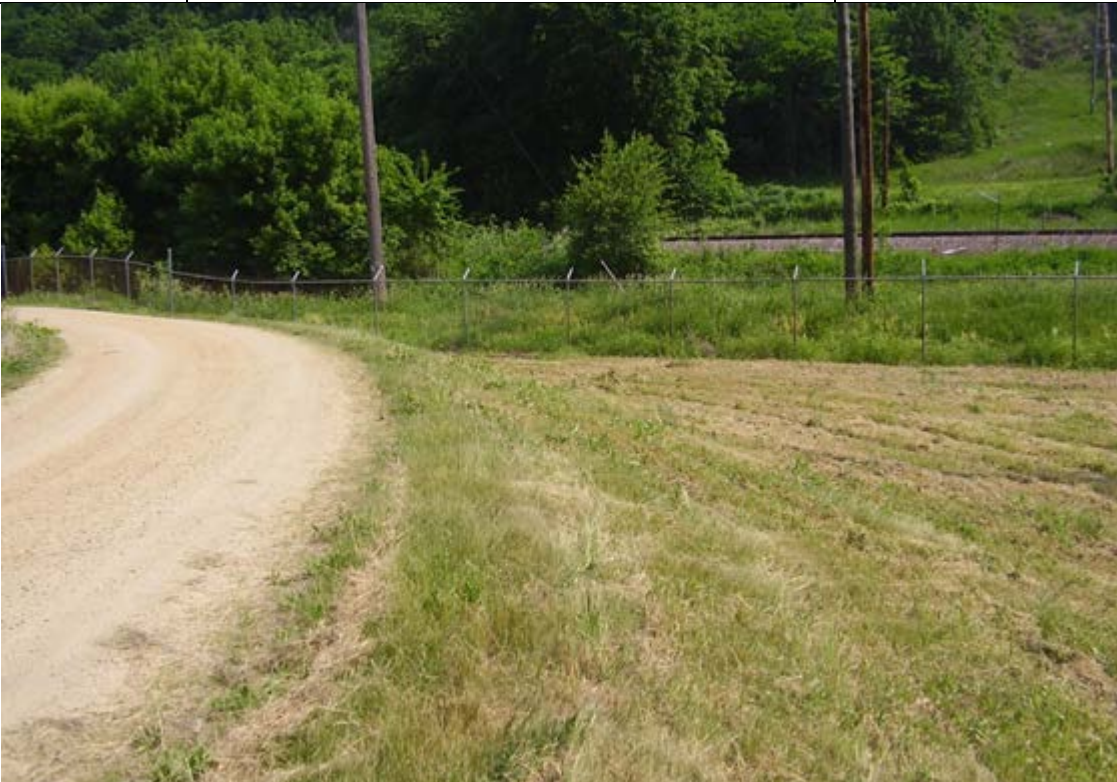
<b>Client Name:</b> U.S. EPA		<b>Site Location:</b> Nelson Dewey Generating Station Cassville, Wisconsin	<b>Project No.</b> 01.0170142.30
<b>Photo No.</b> <b>39</b>	<b>Date:</b> 6/7/11

<b>Direction Photo Taken:</b> North			
<b>Description:</b> Crest and downstream slope of the WPDES Pond.

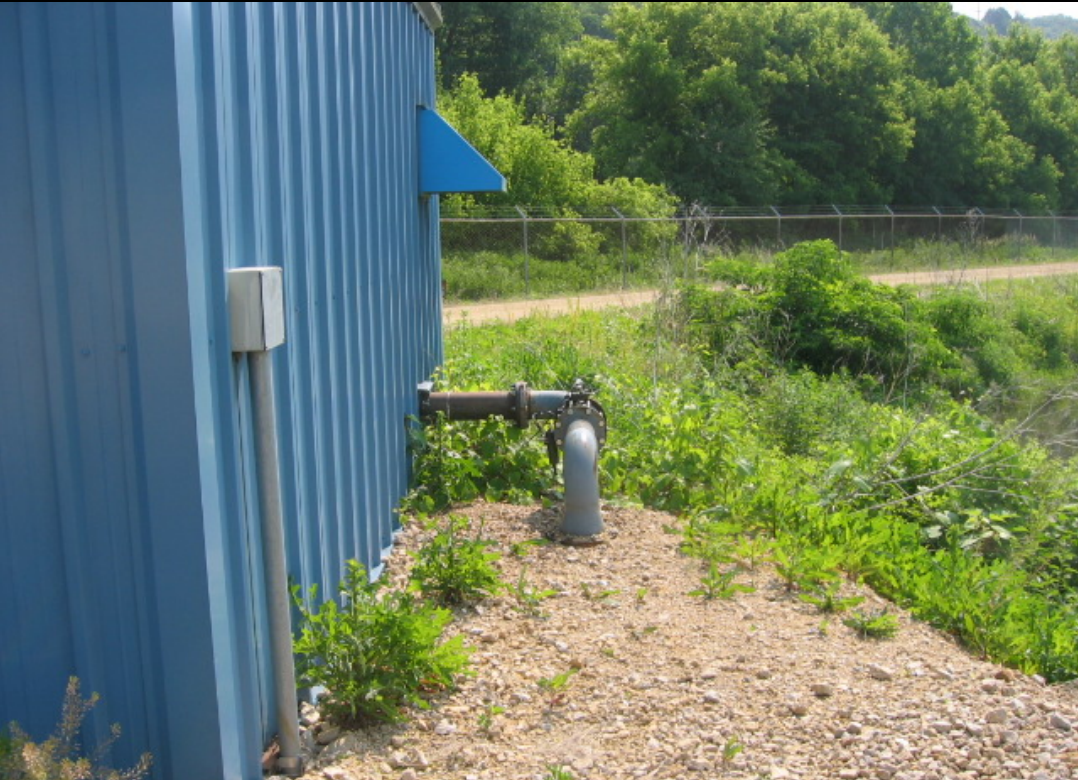
<b>Client Name:</b> U.S. EPA		<b>Site Location:</b> Nelson Dewey Generating Station Cassville, Wisconsin	<b>Project No.</b> 01.0170142.30
<b>Photo No.</b> <b>41</b>	<b>Date:</b> 6/7/11

<b>Direction Photo Taken:</b> East			
<b>Description:</b> Pump house at the WPDES Pond.

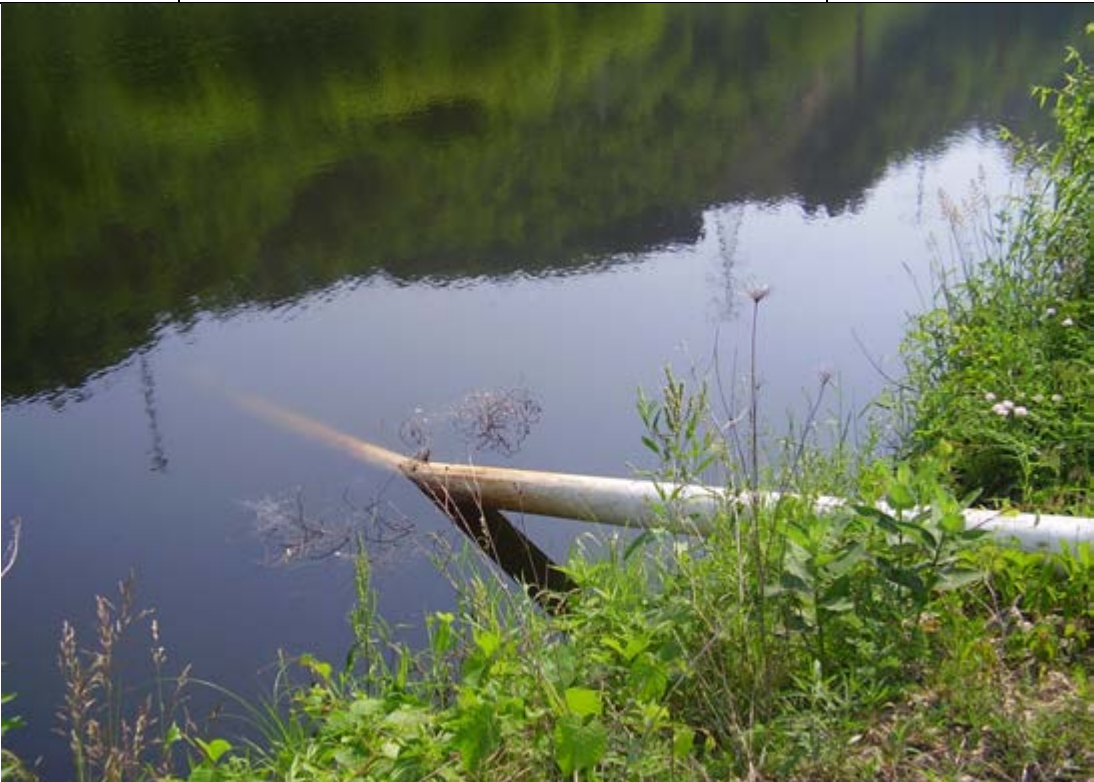
<b>Client Name:</b> U.S. EPA		<b>Site Location:</b> Nelson Dewey Generating Station Cassville, Wisconsin	<b>Project No.</b> 01.0170142.30
<b>Photo No.</b> <b>43</b>	<b>Date:</b> 6/7/11

<b>Direction Photo Taken:</b> Southeast			
<b>Description:</b> Water suction pipe used to collect water for dust control.

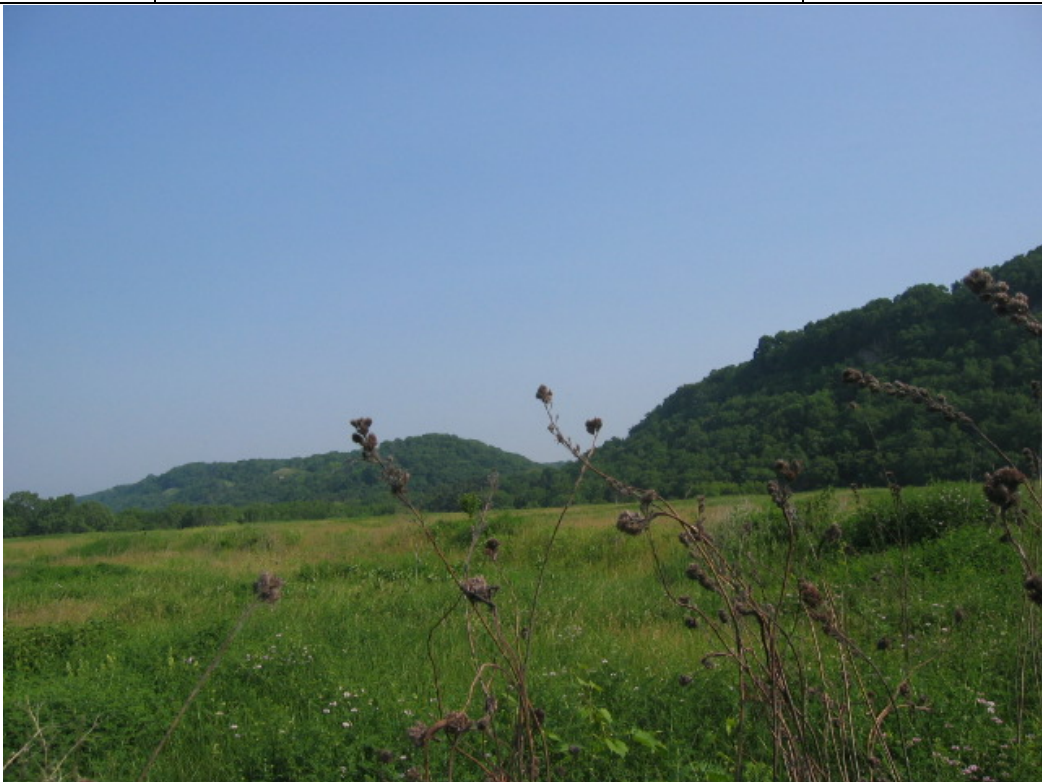
<b>Client Name:</b> U.S. EPA		<b>Site Location:</b> Nelson Dewey Generating Station Cassville, Wisconsin	<b>Project No.</b> 01.0170142.30
<b>Photo No.</b> <b>45</b>	<b>Date:</b> 6/7/11

<b>Direction Photo Taken:</b> North			
<b>Description:</b> Closed landfill portion of the Site.

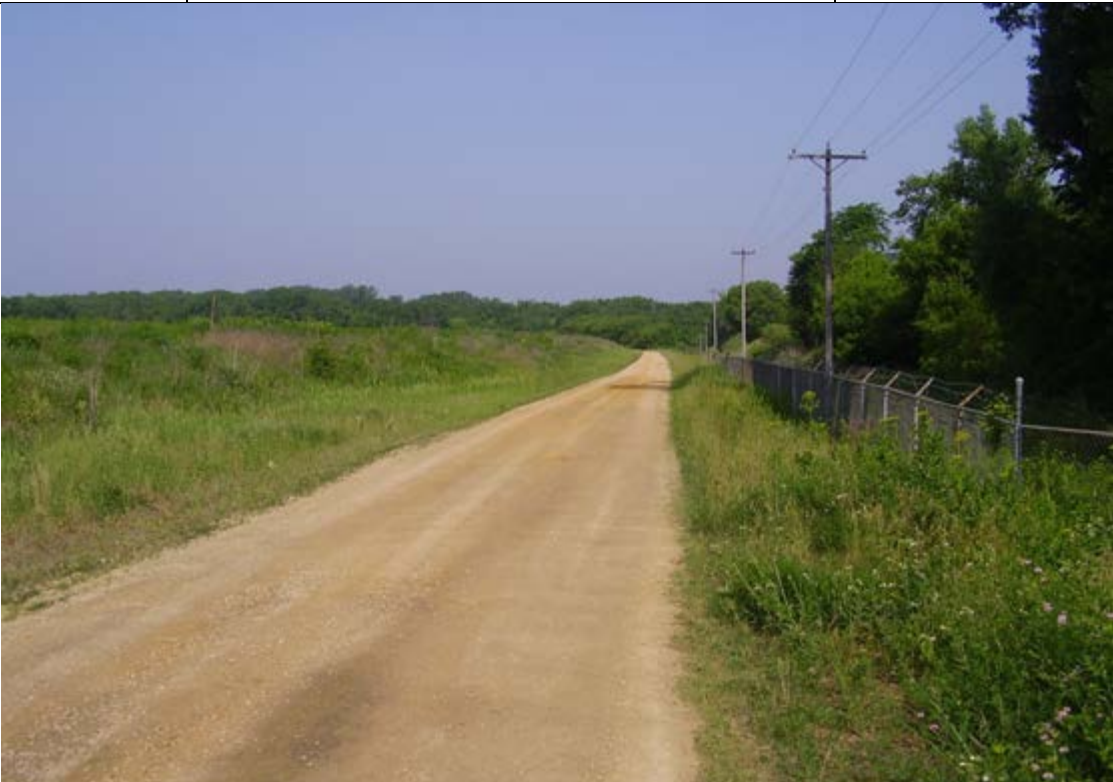
<b>Client Name:</b> U.S. EPA		<b>Site Location:</b> Nelson Dewey Generating Station Cassville, Wisconsin	<b>Project No.</b> 01.0170142.30
<b>Photo No.</b> <b>47</b>	<b>Date:</b> 6/7/11

<b>Direction Photo Taken:</b> Northwest			
<b>Description:</b> Closed landfill portion of the Site.
